# Test Report of Improved Backhoe

**July 2003**

The objective of this test program was to evaluate the operational effectiveness of an improved commercial off-the-shelf (COTS) JCB 215S, Series 3, four-wheel steer (4WS) backhoe equipped with a Rotar International b.v. ROTAR<sup>©</sup>, model HPL 800 S soil sifter mounted on the front of the backhoe (see Figure 1). The Improved Backhoe was tested under conditions approximating those found by humanitarian demining organizations in easy to moderately difficult soil and terrain conditions. The ROTAR<sup>©</sup> subsystem was tested for its ability to remove mines from berms that were created by plowing or tilling operations and to continue to operate after sustaining an AP-mine-equivalent explosive charge. Vehicle on- and off-road handling was evaluated, and logistic considerations (e.g., spares and fuel/oil consumption) of importance to a user were measured and/or noted. Human factors issues (e.g., operator visibility and comfort under various moving situations) and maintenance issues were also addressed.

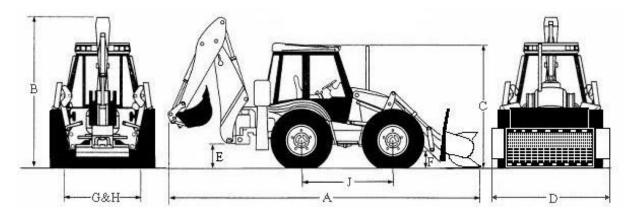
Figure 2. Silhouette of Improved Backhoe

Figure 2 provides a silhouette of the Improved Backhoe. The reader should refer to this figure when as he examines the measurement and weight information in Tables 1 and 2. If the 6-in-1 bucket is also shipped with the Improved Backhoe, an additional 1,830 pounds must be added to the weights in Table 2.
